Subject: EPA Inspection Report - Family Farm

CWA COMPLIANCE EVALUATION INSPECTION REPORT U.S. ENVIRONMENTAL PROTECTION AGENCY, REGION 5

Purpose: Compliance Evaluation Inspection

Family Farm – Photo Log Attachment A

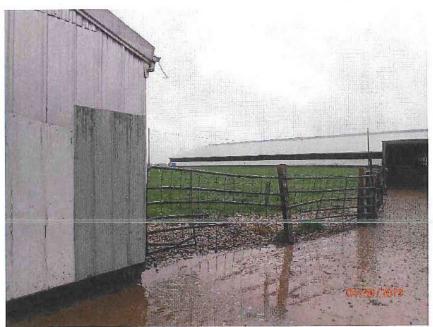
Description: Looking to the yard north of the Cattle Walkway and west of the Free Stall Barn.

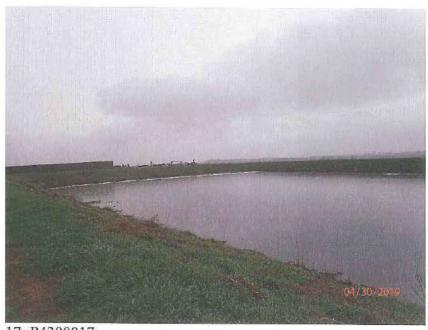
17: P4300017

EPA walked around the berm of the Earthen Storage Structure. The vegetation on the berm was mowed and EPA did not observe any structural issues. EPA observed that the level of freeboard was over six feet.

Description: Earthen Storage Structure is at the north side of the facility.

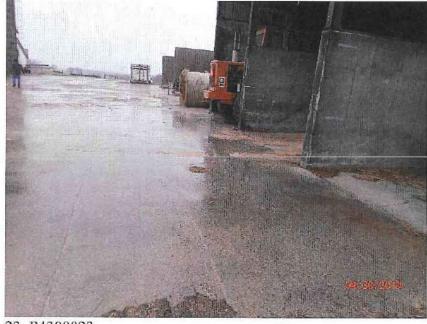
23: P4300023

Description: Commodities and silage bunkers on the Silage Pad. Flow off the Silage Pad is to the south or west.

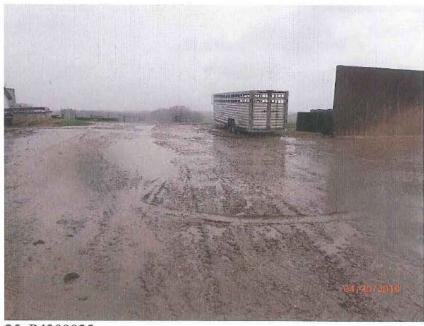
25: P4300025

Description: Some flow from the Silage Pad goes to the west off the pad. EPA did not observe process

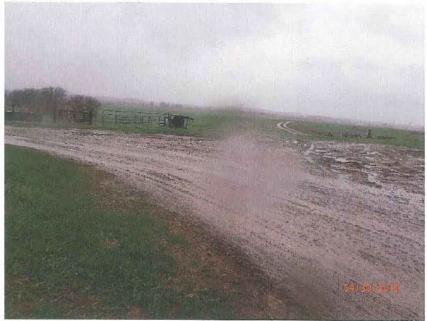
Description: Looking to the west off the Silage Pad. An intermittent tributary is located over 0.6 miles to the west and EPA did not observe any runoff channels to that tributary.

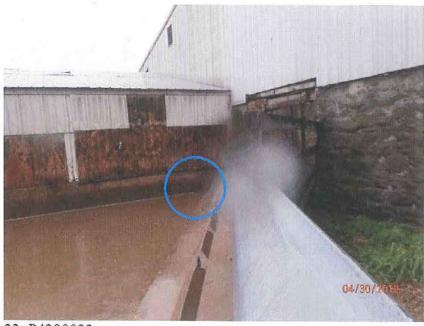
33: P4300033

Description: The wood in the blue circle denotes the location of the stopped-up hole for creating the dam north of the Holding Area.

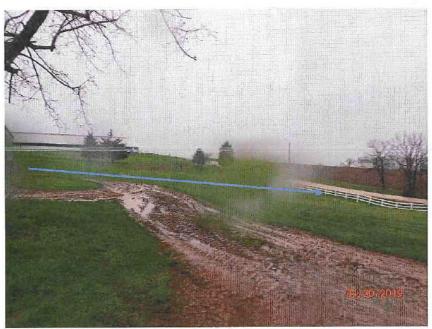
34: P4300034

Description: Facility driveway west of the channel in the front yard. The channel is denoted by a blue arrow.

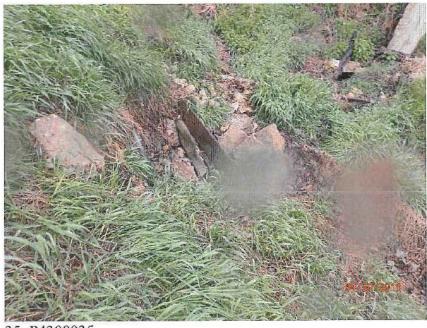
35: P4300035

Description: After flowing under East Welch Road, flow from the Solid Separation Basin exits the culvert in the hillside. EPA walked to the bottom of the hillside and did not take photos until on the way back up.

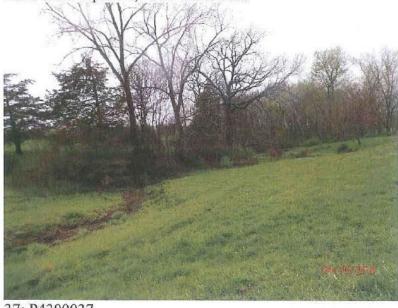
37: P4300037

Description: Looking downstream at the intermittent unnamed tributary.

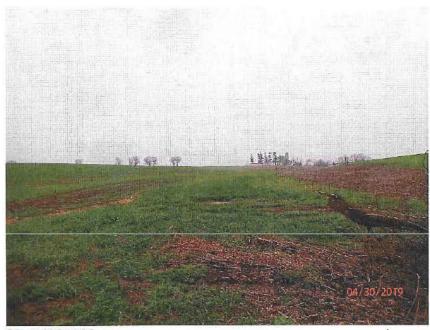
39: P4300039

Description: At the bottom, the slope of the hillside flattens out and EPA could not distinguish a continuous pathway or channel from the flow at the top of the hillside.

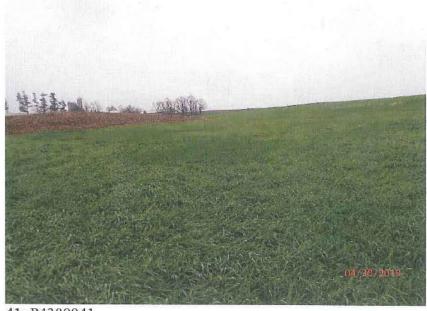
41: P4300041

Description: The facility personnel stated that they harvest the vegetation from the hillside. They also watch for any channelization and if they see any, they fill it in.

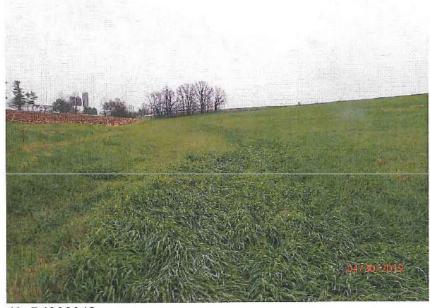
43: P4300043

Description: Walking back north toward the facility, the slope of the hillside increased and there were taller grasses where the precipitation flowed to the south.

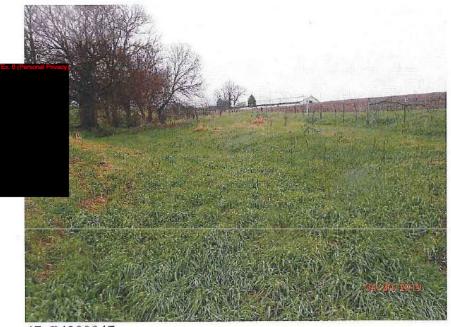
47: P4300047

Description: EPA continued to walk north up the hillside south of East Welch Road. The distance from the

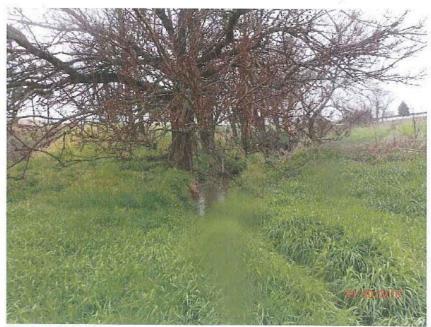
49: P4300049

Description: As the slope of the hillside increased near the top (closer to East Welch Road), EPA documented the channel of flow from the north.
